# 5 Performance of Buildings in Houston's Central Business District

*Although Hurricane Ike's winds were not as high as the current design wind speed, some buildings received extensive exterior envelope damage.*

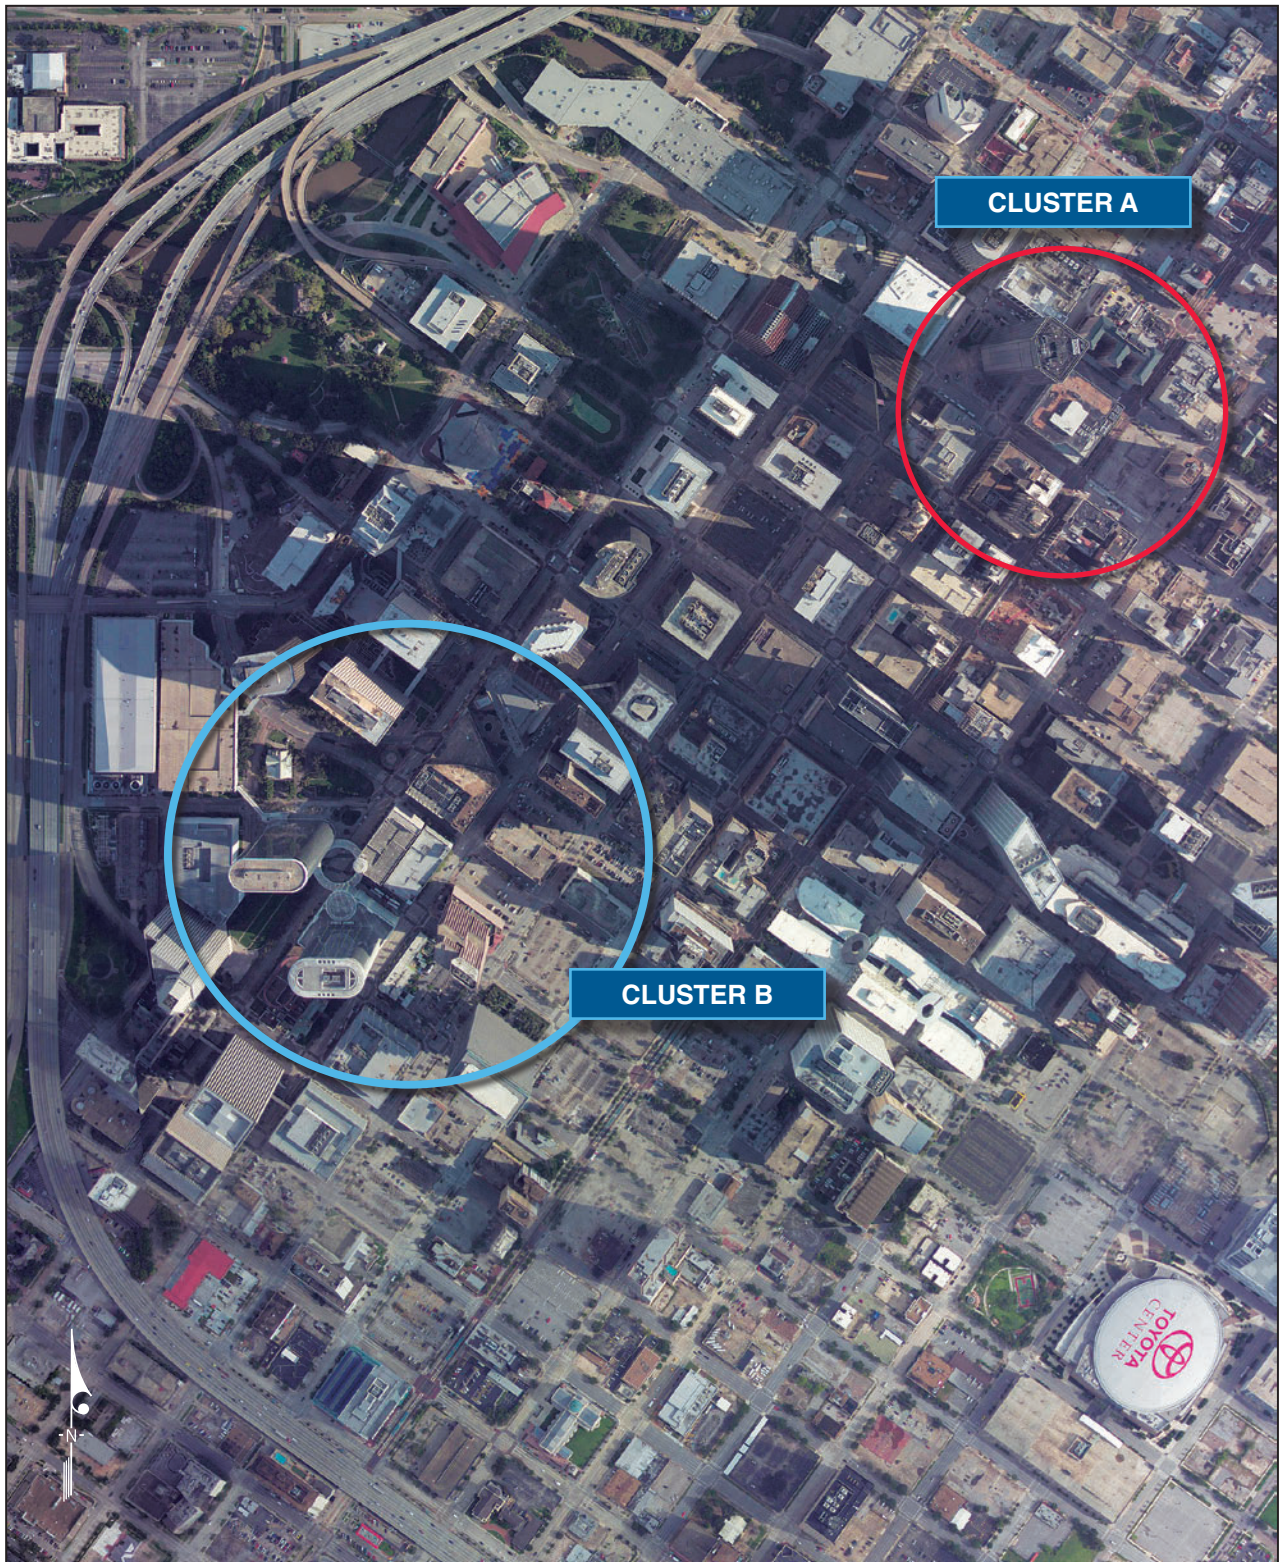
Figure 5-1.

The MAT observed commercial high-, mid-, and low-rise buildings in downtown Houston. The building ages ranged from several decades to just a few years old. Figure 5-1 shows an aerial photograph of a portion of downtown Houston. There was significant building envelope damage in areas indicated by the blue and red circles on Figure 5-1; the red circle denotes buildings that are discussed as cluster A (Section 5.2), and the blue circle denotes buildings discussed as cluster B (Section 5.3). Random isolated envelope damage was observed in the areas outside the clusters, as described in Section 5.1.

View of a portion of downtown Houston. The red circle denotes cluster A and the blue circle denotes cluster B.

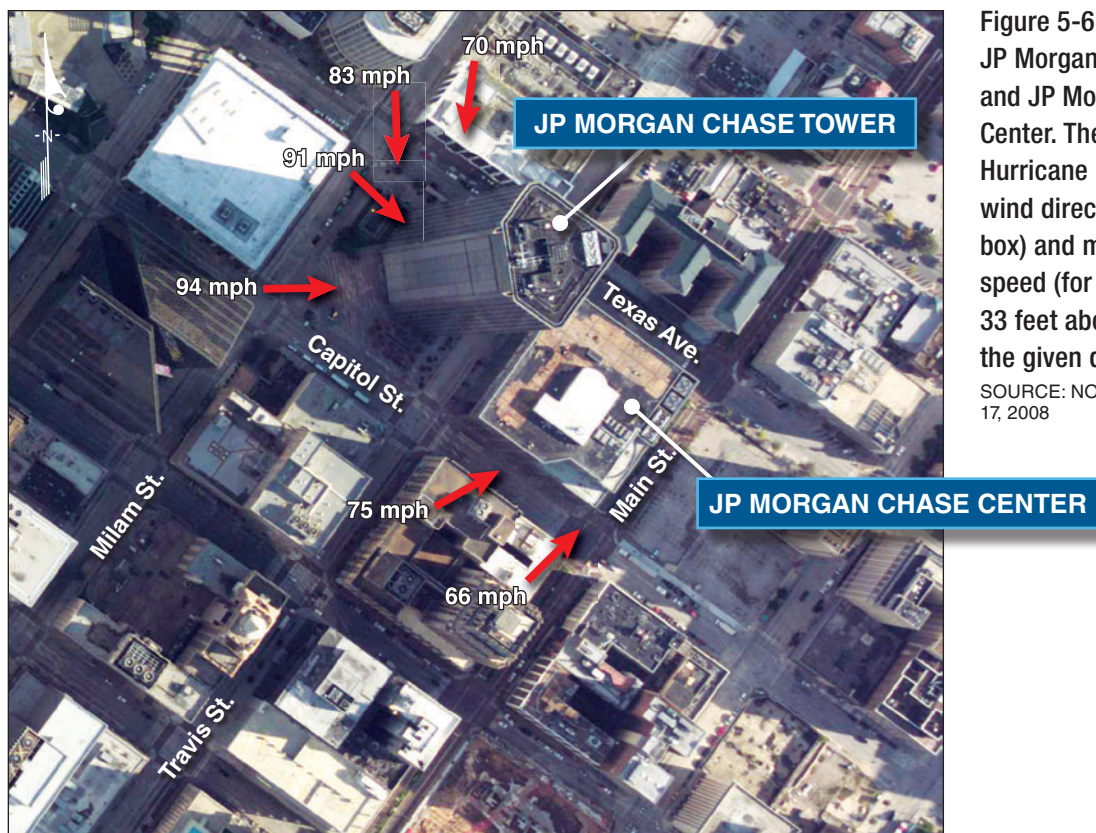
An enlarged view of cluster A is shown in Figure 5-6. The JP Morgan Chase Tower and Center are part of cluster A.

- **JP Morgan Chase Tower.** Built in 1982 and standing 75 stories (1,000 feet), this is the tallest building in Houston. The building never lost power during the event, as power is fed from two vaults from two different substations. This building sustained significant glazing damage (Section 5.2.1).
- **JP Morgan Chase Center.** Built in 1982, this is a 20-story (240-foot) building. Floors 1 through 13 are a parking garage. Floors 14 through 20 are offices. Virtually all of the glazing on one façade was damaged (Section 5.2.1) and the main roof covering was blown off (Section 5.2.4).

Figure 5-6.  
JP Morgan Chase Tower  
and JP Morgan Chase  
Center. The arrows show  
Hurricane Ike's primary  
wind directions (see text  
box) and maximum gust  
speed (for Exposure C at  
33 feet above grade) for  
the given direction.<sup>1</sup>

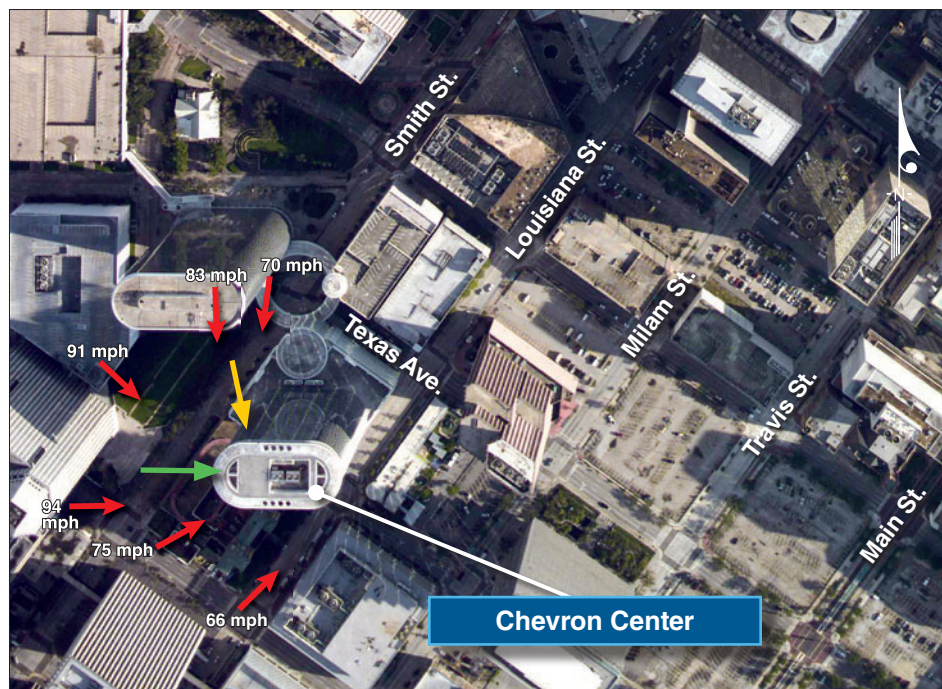
An enlarged view of cluster B from Figure 5-1 is shown in Figure 5-16. The Chevron Center is part of cluster B. This 40-story building was built in 1999–2002. A large number of windows were broken on the side indicated by the yellow arrow in Figure 5-16 (refer also to Section 5.3.1). The roof membrane was blown off the end of the building indicated by the green arrow (refer also to Section 5.3.2). The building lost power during Hurricane Ike and for 2 days afterward.

A substantial amount of glazing damage occurred to the façade of the Chevron Center, indicated by the yellow arrow. The roof membrane blew off from the end of the building (green arrow). The red arrows show Hurricane Ike's primary wind directions and maximum gust speed for the given direction.

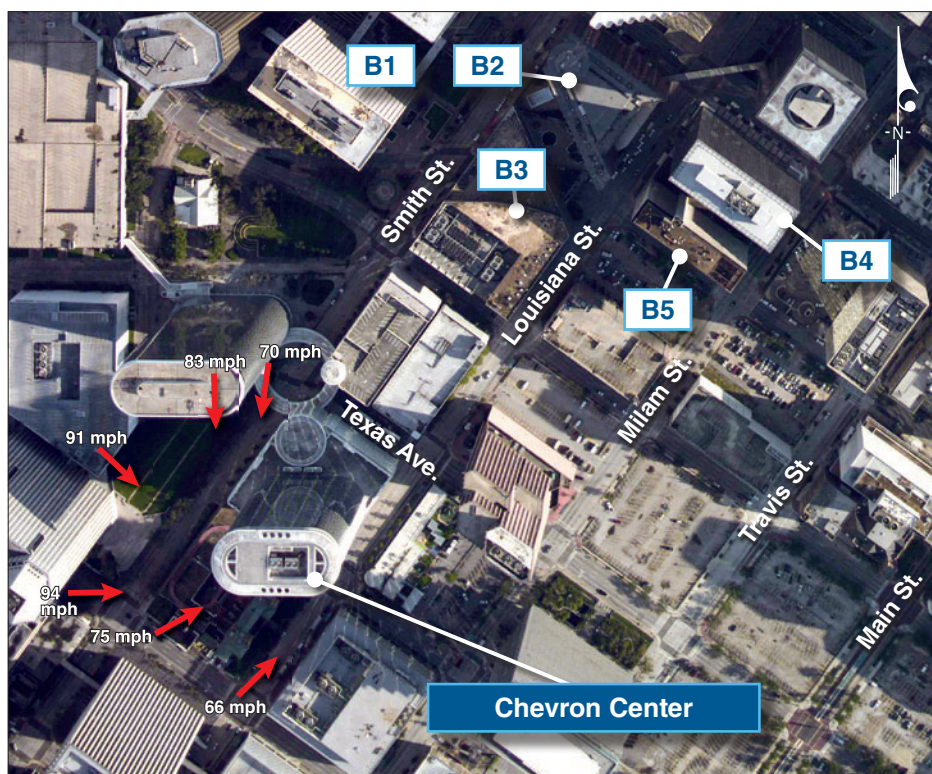
In addition to the glazing and roof covering damage at the Chevron Center, several other low-, mid-, and high-rise buildings shown in Figures 5-22 and 5-23 had various types of building envelope damage as described below.

Figure 5-22.  
Locations of nearby  
damaged buildings

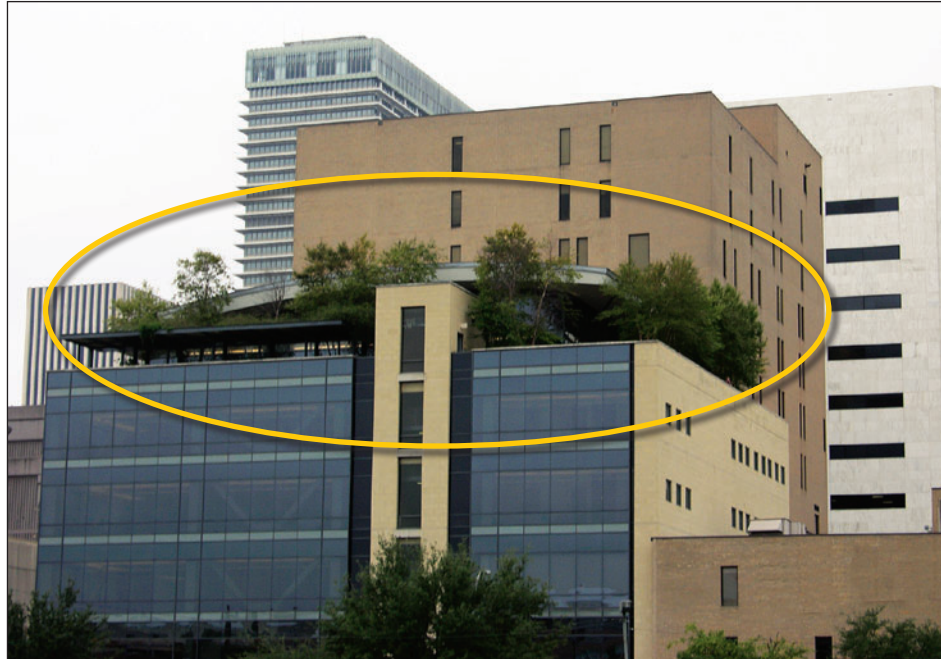
Vegetative roofs can either be “extensive” (with very low plants) or “intensive” (which allows for the planting of shrubs and trees). All three of the vegetative roofs observed by the MAT had trees, as shown in Figure 5-29. The MAT did not perform on-the-roof observations at any of the vegetative roofs, but it was apparent that few, if any, tree limbs were blown away. Lack of limb damage may have been prevented by sheltering from nearby buildings. Also, the low-level wind speeds in the downtown area were not sufficiently high to cause substantial loss of limbs. The concern with limbs is their potential to damage glazing if they are blown away, particularly when trees are placed many floors above grade.

**Figure 5-29.**  
**View of a vegetative roof**  
**in the downtown area**
